STRESS-CORROSION CRACKING  
OF HIGH-STRENGTH ALLOYS

A Report To  
U. S. ARMY ORDNANCE CORPS  
FRANKFORD ARSENAL

Report No. 2684 (Final)

September 1963

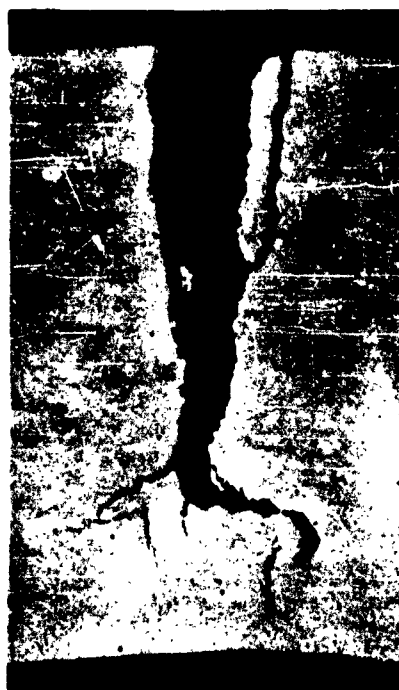
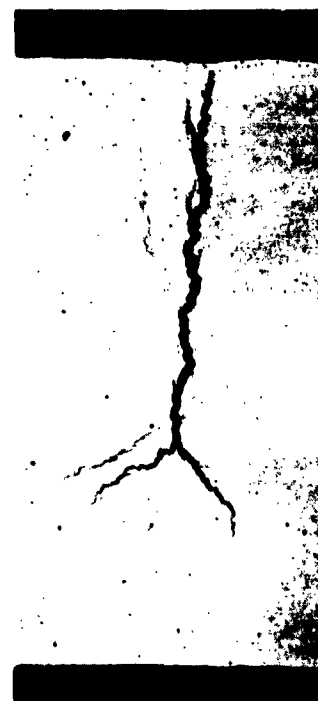
Surface of Annealed-and-Aged 18%-Nickel  
Maraging Steel Cracked in Chromate  
Solution (Approx. 1X)

Longitudinal Section Through Cracked Area  
Showing Main Crack (left) and Branch Crack  
(right) (50X)

Stress-Corrosion-Crack Pattern in 18%-Nickel Maraging Steel (I-1)

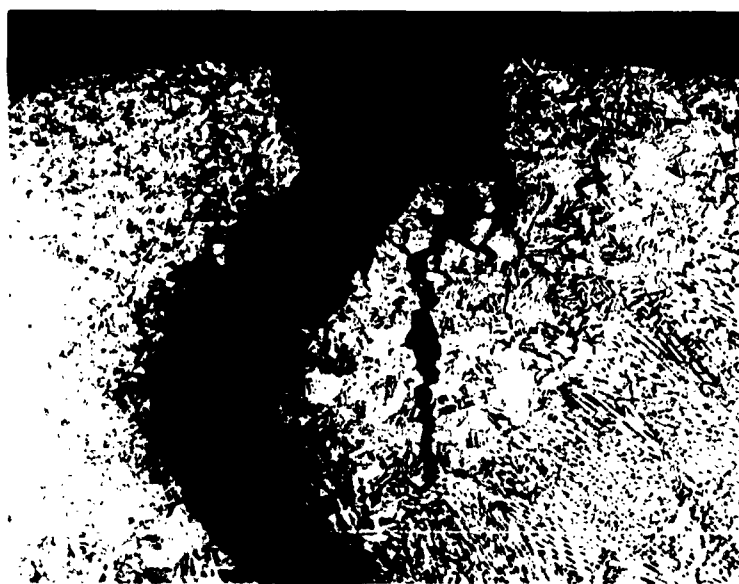
Cross-Section of Welded and Aged 18%-Nickel Maraging Steel After 55 Days Immersion in 4% Soluble Oil Solution.

Enlarged View of Fracture Origin in Weld Heat-Affected Zone. Etchant is Diluted Marbles Reagent. (80X)

Failures in Welded Samples
